Scoop to Win – A Survey of Dog Waste  
in the Nisqually Reach and Henderson Inlet Shellfish Protection Districts

Aimee Christy  
Pacific Shellfish Institute  
120 State Ave NE #1056  
Olympia, WA 98501  
[www.pacshell.org](http://www.pacshell.org)

November, 2011

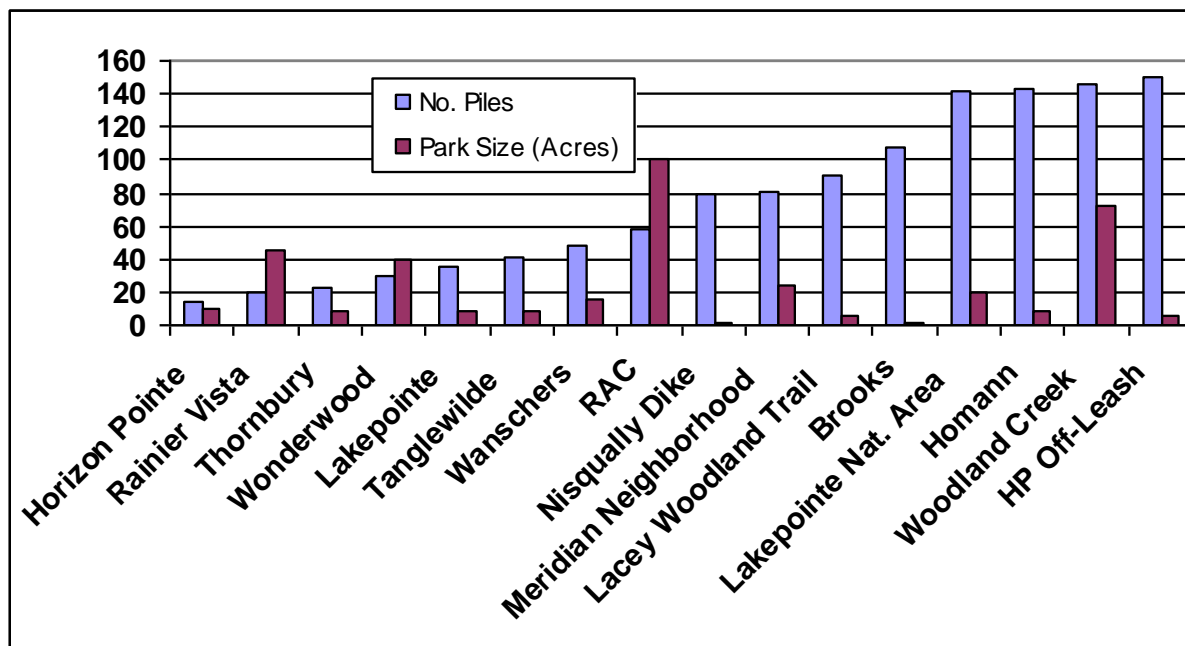
Figure 2. Comparison of dog feces collected at 16 locations within the Henderson Inlet and Nisqually Reach SPDs.

In total, staff removed 1208 piles of dog poop totaling 127 pounds from 16 locations throughout the SPDs (Figure 2). The number of poop piles ranged from 14 to 150 at Horizon Pointe Park and the Hawks Prairie Off-Leash Park respectively. Park size represents the entire acreage of the park and not the amount of ground surveyed. Because dog waste contains 23 million fecal coliform bacteria per gram (Schueler 2000), its removal prevented 1,324,942,232,000 fecal coliform units from potentially entering groundwater, stormdrains, waterways and ultimately Puget Sound. This number is an approximate estimation since each pile varied significantly in terms of light exposure and water content.

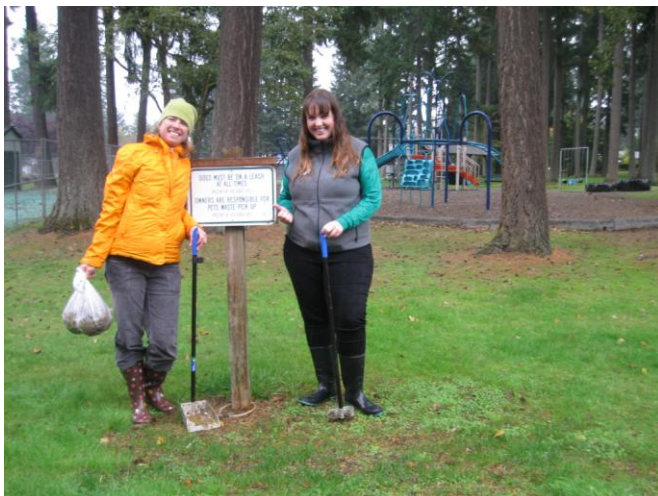
**Description:** Tanglewilde is a neighborhood park with grassy fields, playground, tennis court and adjacent community pool. The park is surrounded by single family homes on all sides. Pet waste signage and garbage cans were present, but no pet waste station.

**Compliance/Problem Areas:** No problem areas were detected. One compliant dog walker was observed and had a strong understanding of urban pet waste issues.

**Conclusions:** Dog waste was not a problem during this visit.

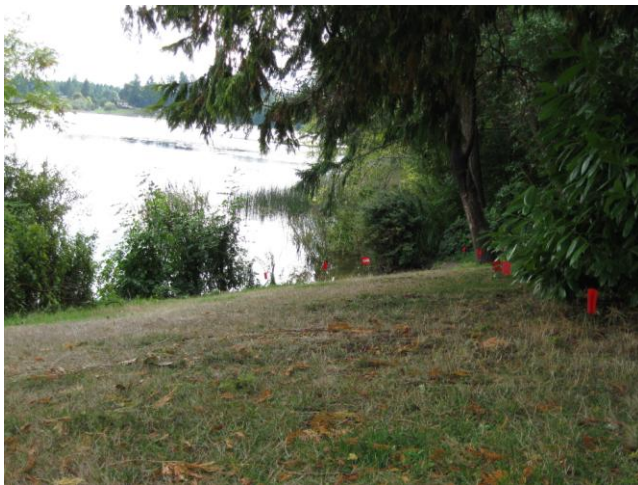
**Compliance/Problem Areas:** Poop piles were dispersed lightly along the trails. Two problem areas were identified: one approximately 25 feet northwest of the pet waste station and another on a grassy slope adjacent to Hicks Lake. Two dog walking parties were observed – one was noncompliant.

**Conclusions:** Pet waste was detected along banks of Hicks Lake. Increased park use during warmer summer months may increase the amount of poop piles detected.

**Photo:** Thirteen flagged poop piles on slope along Hicks Lake.

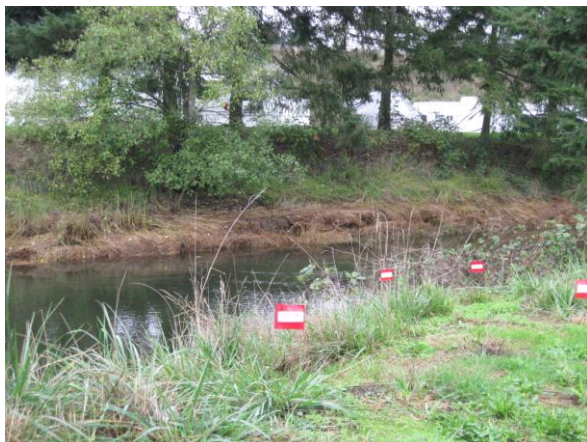
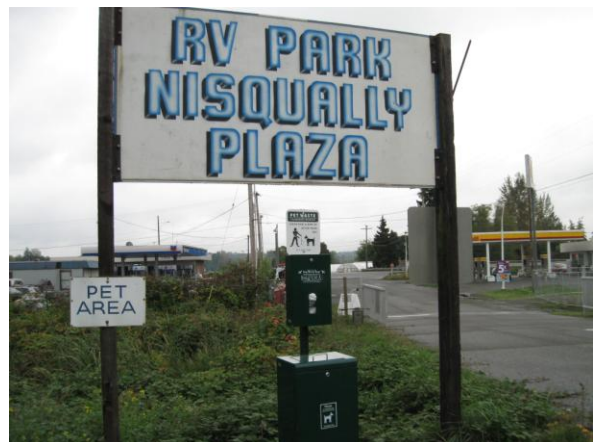
**Compliance/Problem Areas:** Despite the pet waste station, many piles of dog poop were observed along the dike. Several piles were removed from the sloping banks of McAllister Creek. The park owner expressed extreme frustration regarding the issue and reported that compliance is a constant battle between him and his tenants. Several dog owners were observed using the trail after eating at the nearby restaurant. The area is also used by dog owners purchasing gas at the adjacent stations.

**Conclusions:** Pet waste is a water quality concern at this location due to the large volume of feces in close proximity to McAllister Creek. Long grass may protect the waterway, but also serves as an attractive place for dogs to defecate. Increased signage, distribution of fliers, native plant enhancement, and additional outreach is recommended at this site.

**Photos:** Pet waste along McAllister Creek (left) and proximity of dike to nearby gas stations, restaurant, and tavern (right).

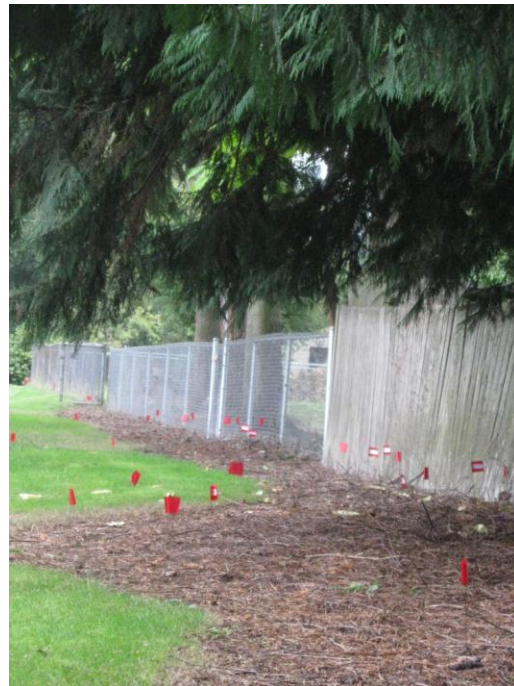
**Compliance/Problem Areas:** Numerous piles were flagged along the southern fence line both near the parking lot and the access strip to the west. Piles were also detected at the access point on the northwest corner of the park. All dogs observed (3) during the visit were off-leash. The garbage can did not contain any properly disposed of pet waste bags.

**Photo:** Flagged piles along the southern edge of Brooks Park.

**Conclusions:** Brooks is one of the few Lacey parks without a pet waste station. One to two stations should be installed near the parking lot and western access point. Outreach to surrounding neighborhoods is also recommended. This location has been suggested as a site for a future off-leash park. Conversion *may* improve the amount of un-scooped dog waste via social pressure and site maintenance by organized dog-advocacy groups.

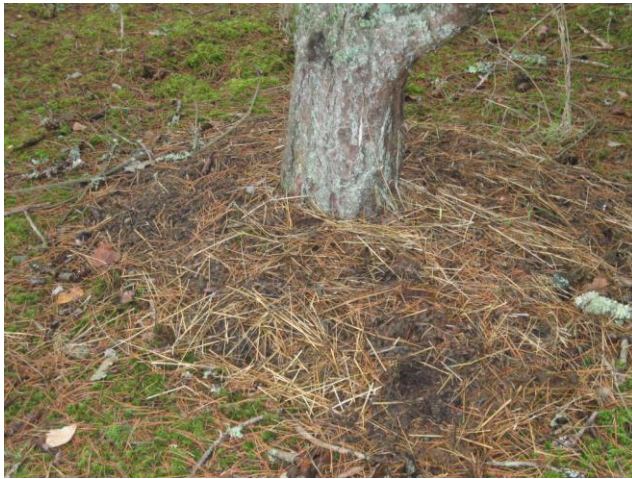
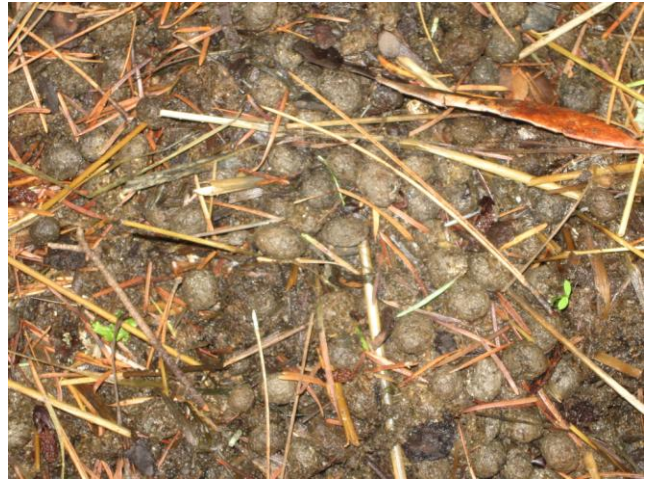
**Compliance/Problem Areas:** This site is commonly used as an unofficial off-leash park. Large quantities of pet waste were found along the trail running parallel to the AmTrak rail lines. No piles were seen along the shores of Pattison Lake. Additional problem areas were found in clusters on the west side of the property along trails and under trees. One individual was seen cleaning up after his dog and commented that he picks up when it is directly on the trails, but not in the woods. Two non-compliant owners were observed. Pet waste composting was observed at several locations. One pile of dog poop 1' x 2' x 2' was uncovered equaling approximately 30 piles, or 2 pounds. Rabbit waste mixed with straw was spread around the bases of three trees. Yard waste dumping and littering were also common at this site.

**Photos:** Rabbit composting around bases of several trees.

**Conclusions:** Installation of pet waste stations and garbage cans are recommended for this site. While not an official park, this natural area is often used for recreation and dog walking. Similar to other natural areas surveyed, the amount of flagged pet waste suggests that users are comfortable with “dogs pooping in the woods” and do not see this as a concern. The high number of stepped-on poop piles suggests that users do not remain on the trails at all times, however, and are at risk of tracking feces into their cars and homes. Educational outreach regarding pathogens found and transmitted by dog waste is recommended.

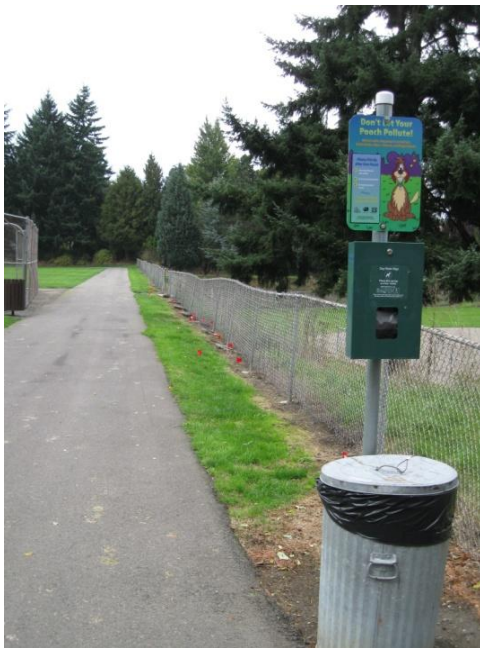
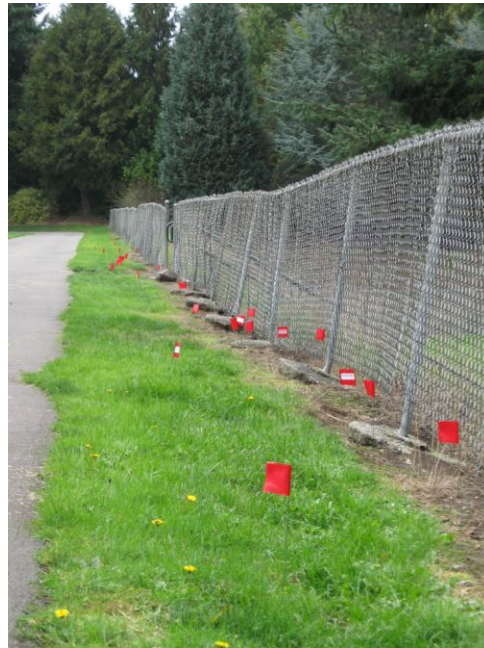
**Compliance/Problem Areas:** Large quantities of dog waste were found at this location. Three main problem areas were detected along: 1) the fence line just east of the soccer field, 2) the wooded access trail on the northwestern corner, and 3) the west edge of the property adjacent to Glen Mary Lane SE. Many dog walkers were observed –most were compliant and two were not. Several owners used the fenced baseball field as an off-leash area and did not clean up after their dogs. One non-dog owner residing in the apartment complex north of the park informed me that she scoops her yard frequently to protect her small children who often enter her home covered in dog feces. After scooping the poop, she dumps it in the “thorny bushes” nearby. She has urged her property manager to build a fence between the park access trail and her backyard to keep dogs out. Staff from Lacey Parks Maintenance informed me that the current amount of dog waste “is nothing compared to what it is during the summer when the park is more frequently used.” Staff also expressed concern for the home school children that use the soccer field every Friday from 9-1.

**Photos:** Scoop to Win flags marking approximately 40 poop piles along fence line.

**Conclusions:** This park is a good candidate for increased outreach and possibly code enforcement. An additional pet waste station should be placed at the wooded access trail on the northwestern corner of the park. Fliers and additional information should be provided to the apartment manager and neighborhood associations for distribution. One individual recommended that Lacey Elementary be involved in the process in some fashion.

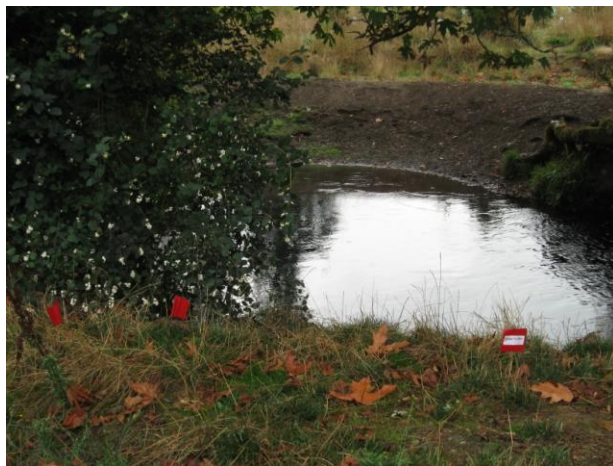
**Compliance/Problem Areas:** Woodland Creek has historically been used as an “unofficial” off-leash park, as was the case during the site visit. Several owners were observed not cleaning up after their pets. One individual believed that her dog had pooped in the “designated poop area.” This area, approximately 20 feet south of the foot bridge on the west side of the main trail, contained very high densities of dog waste in relatively close proximity to Woodland Creek. Three piles were found directly on the edge of the creek. Many piles were dispersed throughout the native vegetation plantings and tall grass in this southwest portion of the park. Another problem area was located northeast of the footbridge among the grasses and shrubs. Many properly-disposed-of poop bags were found in the garbage cans.

**Photo:** Poop piles adjacent to Woodland Creek. Constructed berm depicted in background.

**Conclusions:** The high volume of dog waste found at this park may pose a risk in terms of human health and water quality. Improvements have been made (i.e. pet waste stations, garbage cans, tall grass, native plant restoration, berm construction) to reduce the amount of fecal coliform entering the creek. Code enforcement is recommended.

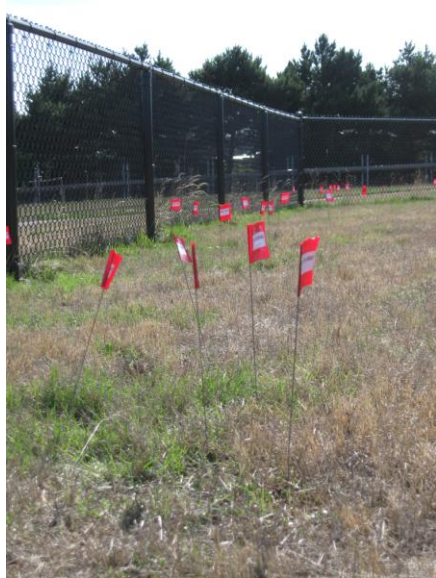
**Compliance/Problem Areas:** Many owners were observed cleaning up after their pets and several claimed to pick up other dog's poop as well. A sign at the entrance kiosk encourages individuals to clean up *any* poop that they see since "we all miss a few." Social distraction resulting from the fun, interactive nature of the park may account for the high number of poop piles flagged. The fence line along the far eastern edge of the property had the highest density of piles.

**Photo:** Flagged piles along the eastern edge of the fence line at Hawk's Prairie Off-Leash Park.

**Conclusions:** Despite the high number of piles flagged, off-leash dog parks may be beneficial in terms of dog waste pollution. Properly sited off-leash parks contain high volumes of dogs in a safe, contained, controlled environment. Cleaning up after pets is the "social norm" at off-leash parks and this behavior is often enforced by other dog owners. Organized dog advocacy groups can also assist with site maintenance and outreach.
